**DEFENDANT STATE FARM FIRE AND  
CASUALTY COMPANY'S EXPERT  
DISCLOSURE**

**NORRIS PIPE AND SOIL DAMAGE INVESTIGATION**

**NORRIS DAMAGE REPAIR COST ALLOCATION**

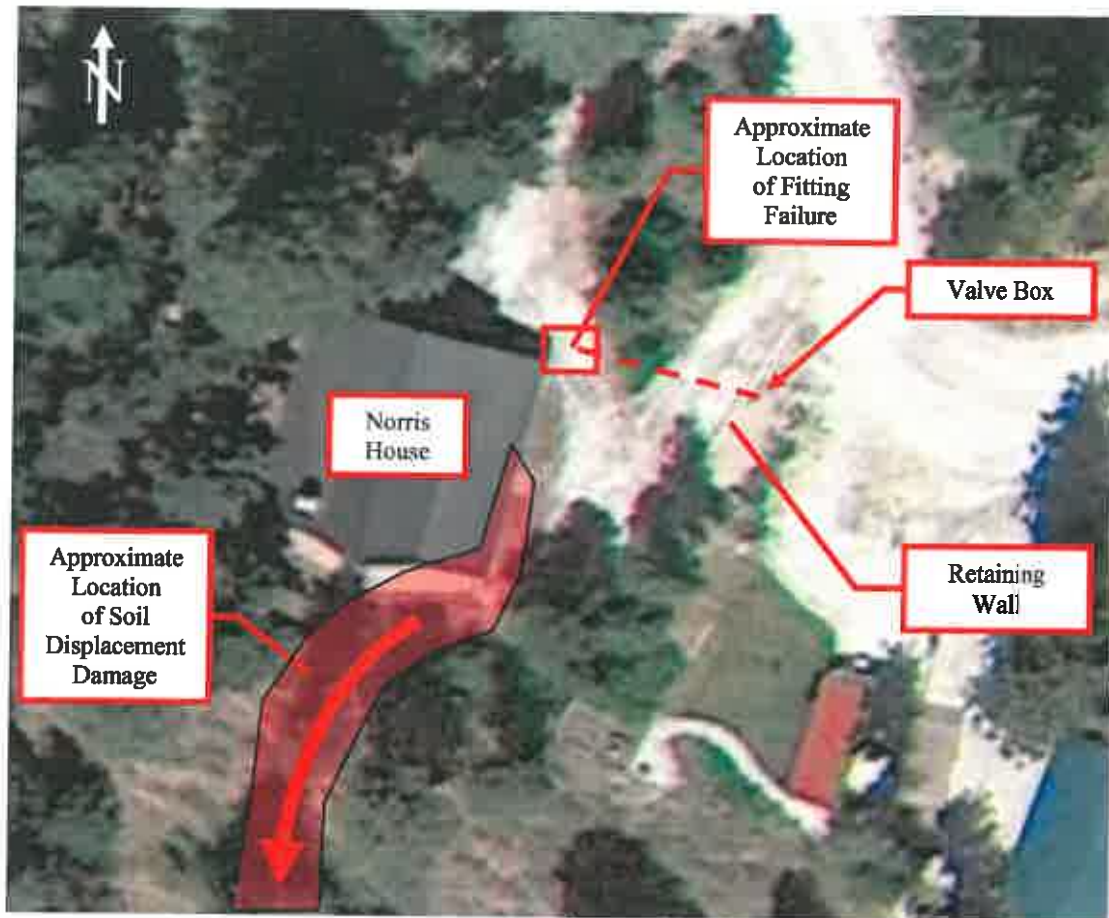
**Figure 1 – Aerial Image (Source: Google Earth)**

A site investigation was performed by CASE on December 7, 2013. Site conditions were clear and approximately 18°F. There was up to 12 inches of accumulated snow on the ground, the surface of which was frozen. Hand excavation and/or probing of the soils adjacent to the house was not possible due to the frozen grade conditions. A large quantity of the foundation backfilled soils along the south two-thirds of the east side of the house and east half of the south side of the house had been displaced downslope to the south, toward the Wenatchee River. Figure 1 below is an aerial image of the property with elements of interest identified. The dashed red line indicates the approximate position of the 1 inch diameter PVC domestic water supply line. The red rectangle indicates the location of the buried and failed fitting in the domestic water supply line. (Figure 1)

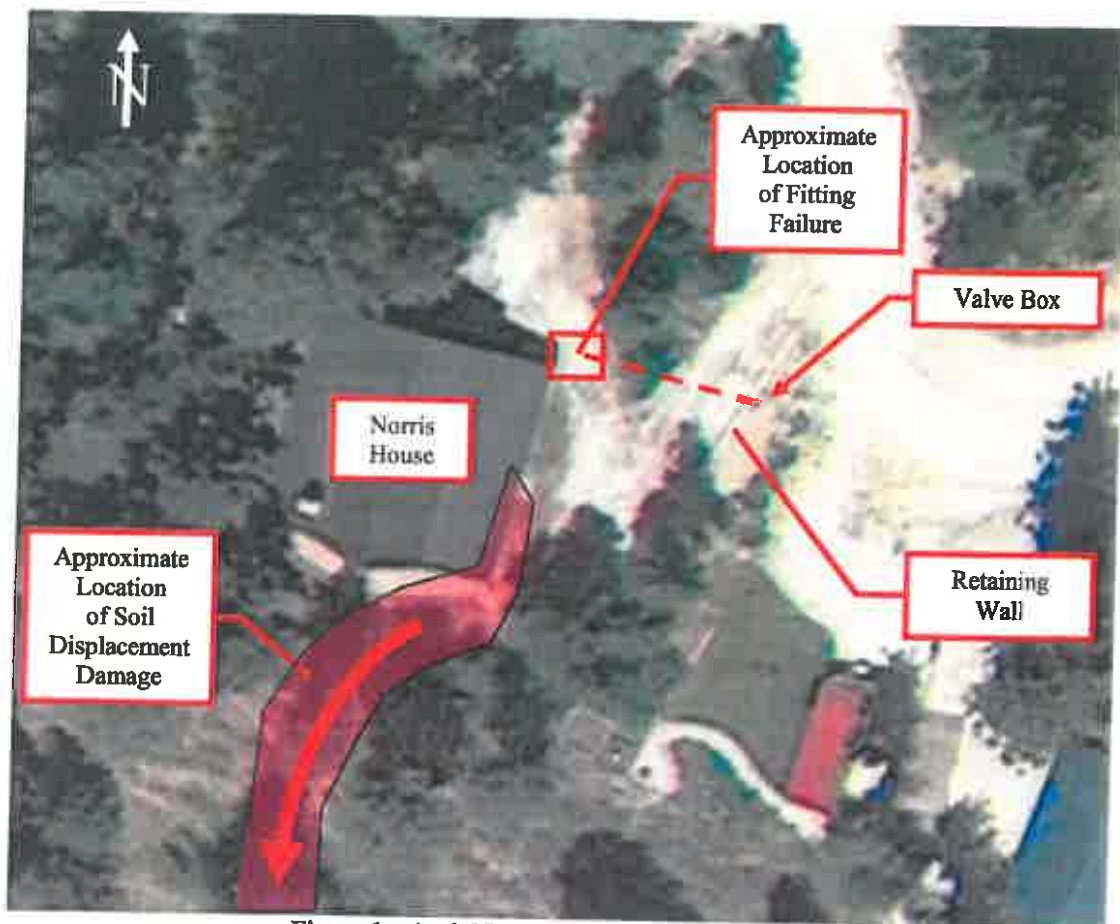
**Figure 1 – Aerial Image (Source: Google Earth)**

1. Below is an aerial image of the property with elements of interest identified. The dashed red line indicates the approximate position of the 1 inch diameter PVC domestic water supply line. The red rectangle indicates the location of the buried and failed fitting in the domestic water supply line.

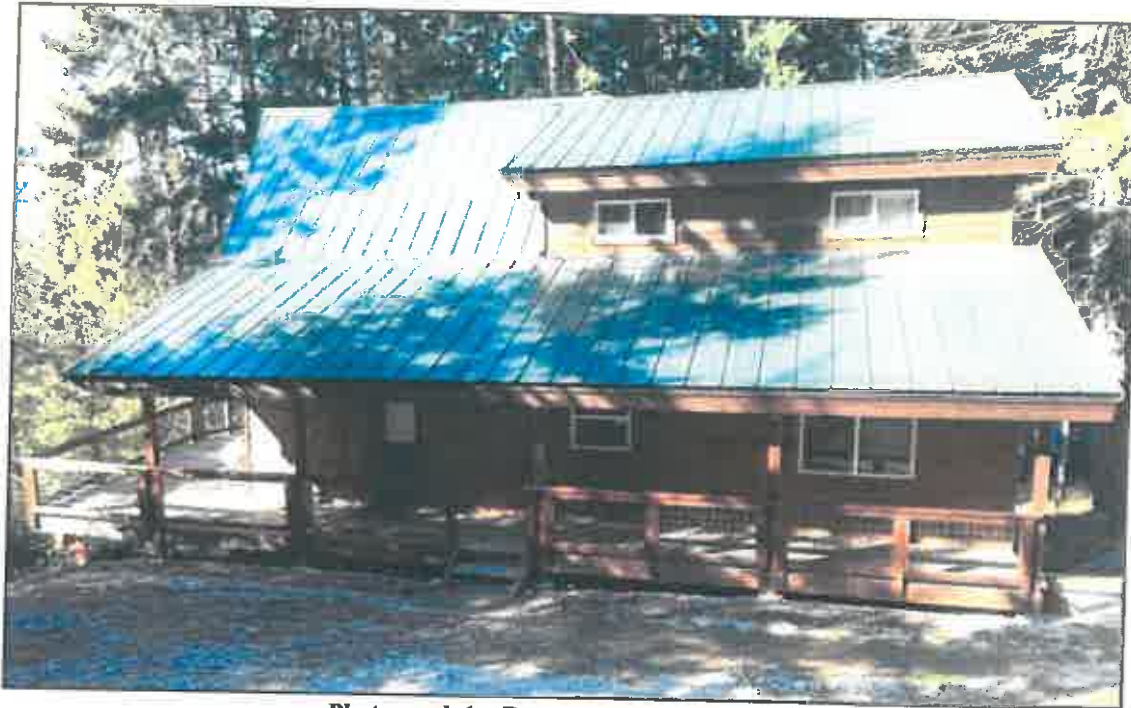
2. The residence is a two story, wood framed building constructed over a partial basement. The exterior wall faces of the home are finished horizontal lap wood siding. The roof is finished with metal roof panels. (Photograph 1)

**Photograph 1 – East elevation, prior to loss**  
**(Photograph courtesy of the insured)**
